**California State Board of Equalization**  
450 N Street, Sacramento, California

**Mold Remediation – 20<sup>th</sup> Floor**  
**Closure Report Addendum**  
*Project No. 2372.02-572*

**Closure Report Date:** November 30, 2010  
**Addendum Date:** October 31, 2012

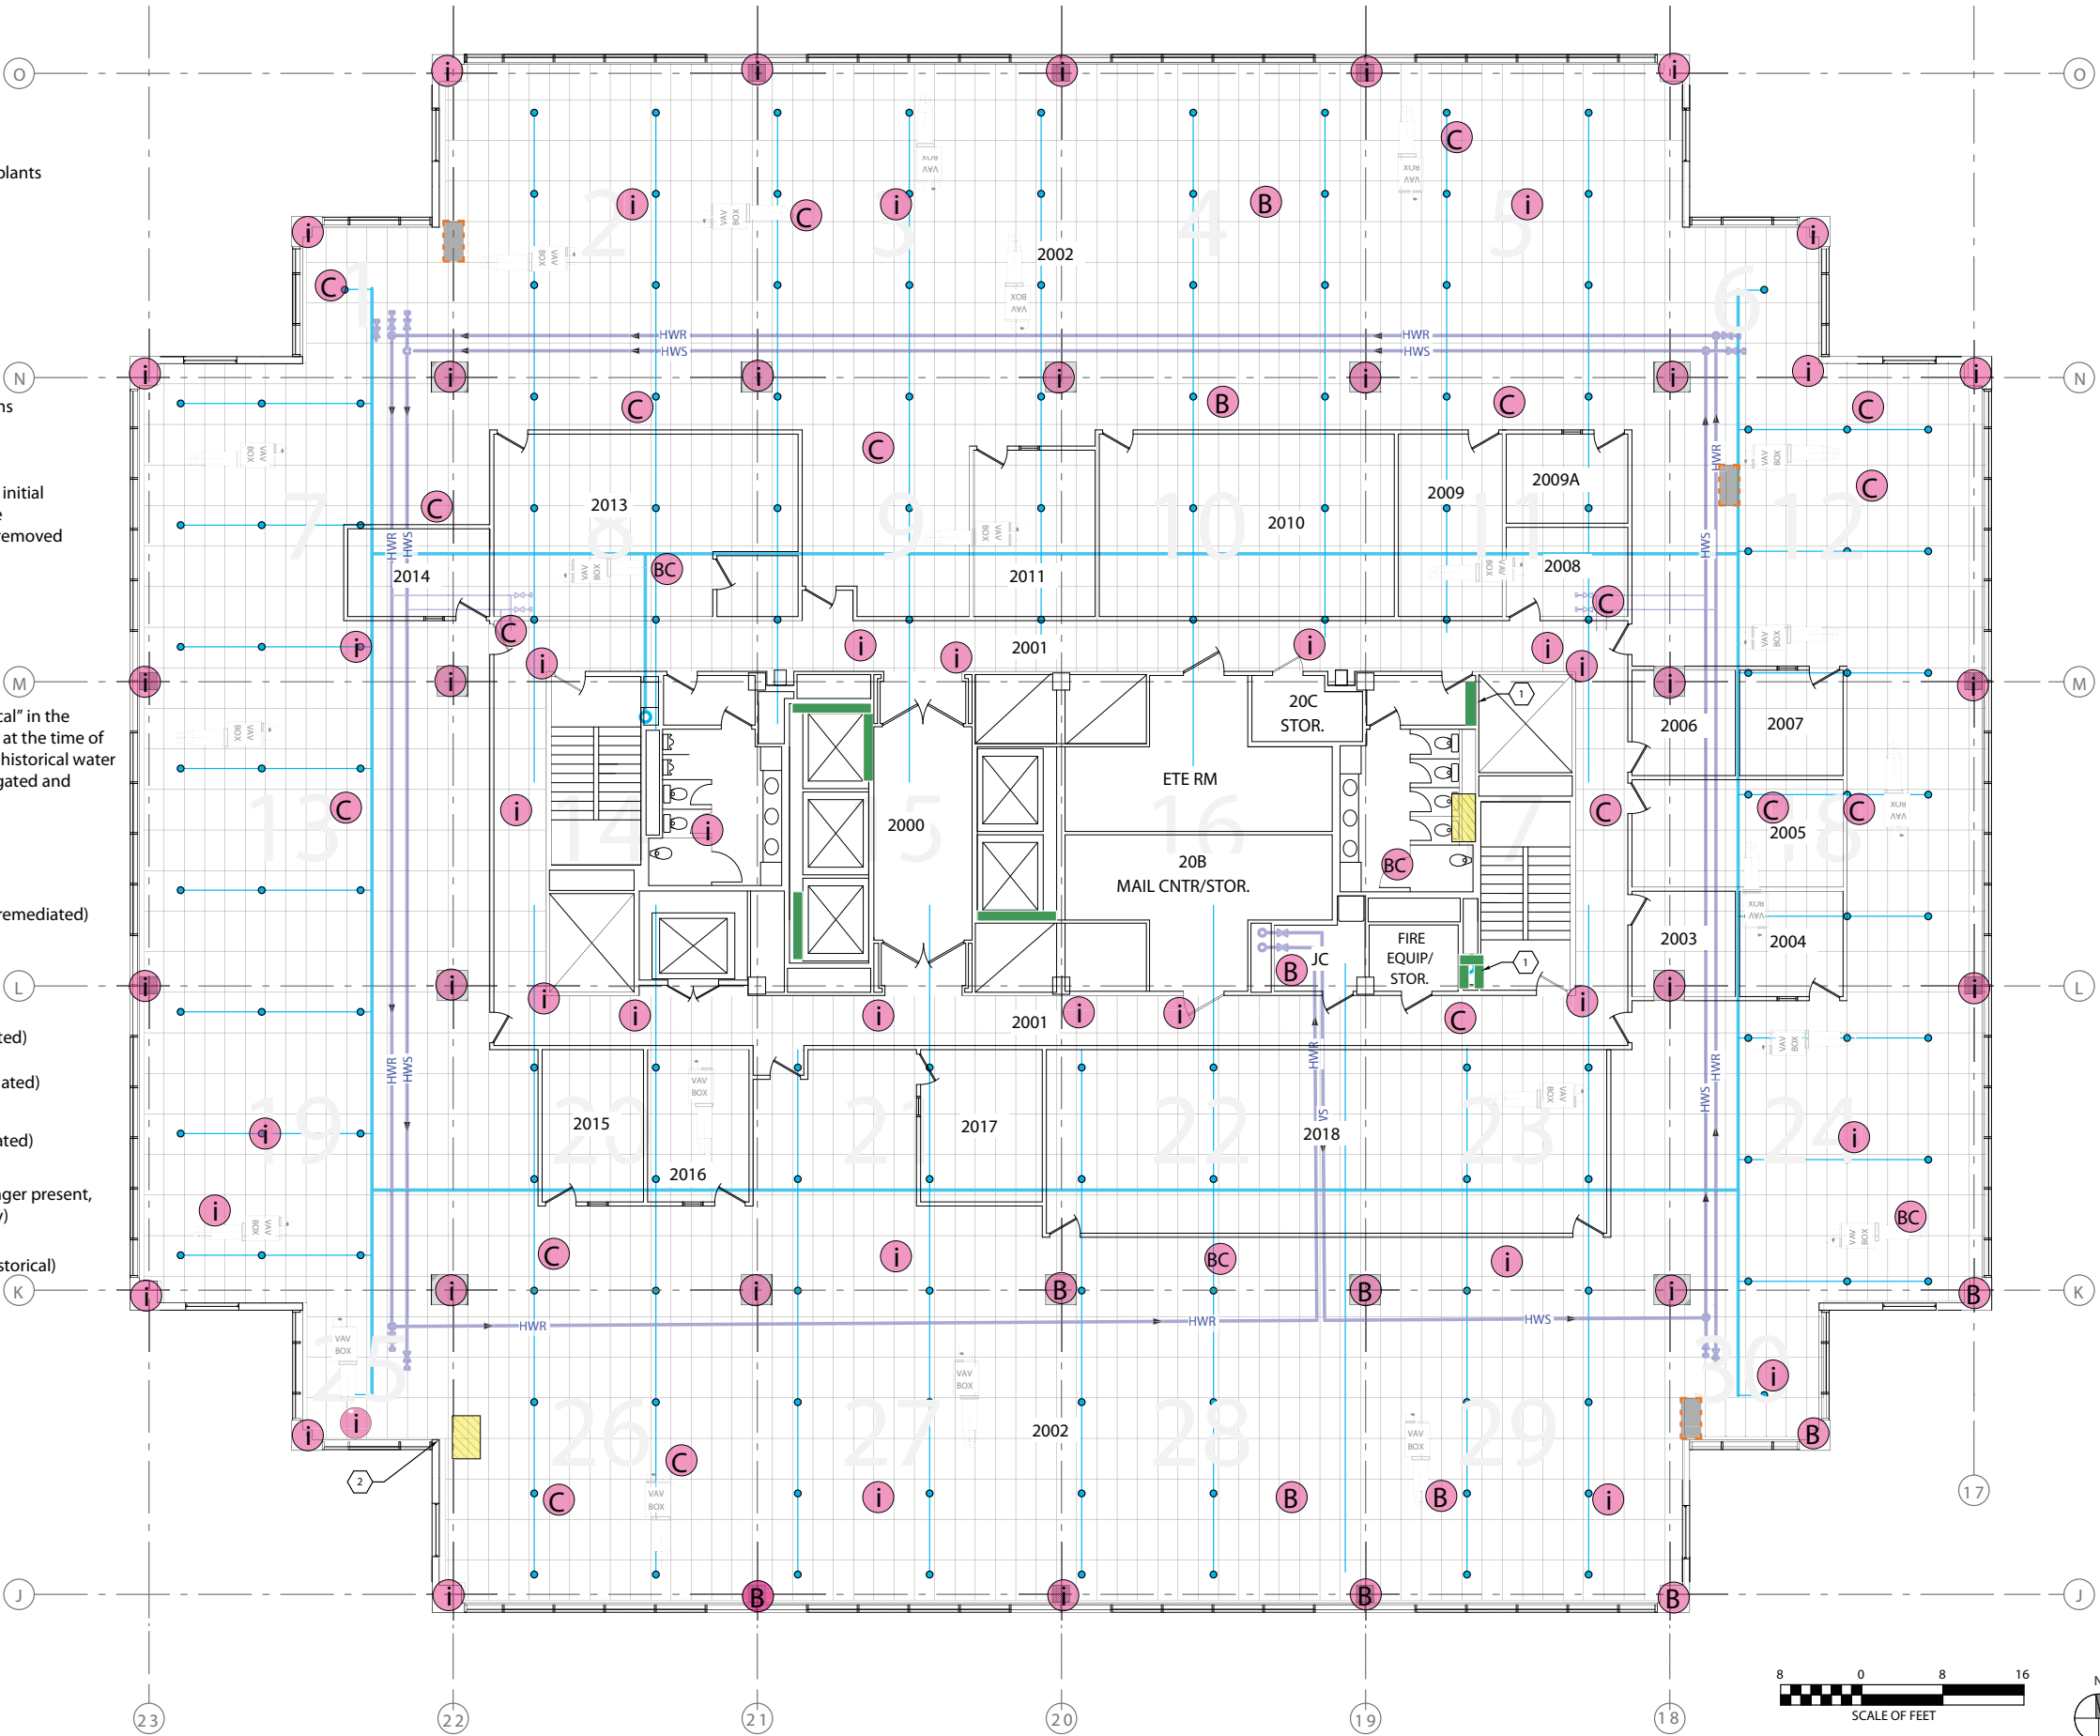
- ① 10 Sq. ft. visible mold growth
- ② Floor stain from over-watered plants without drip pans

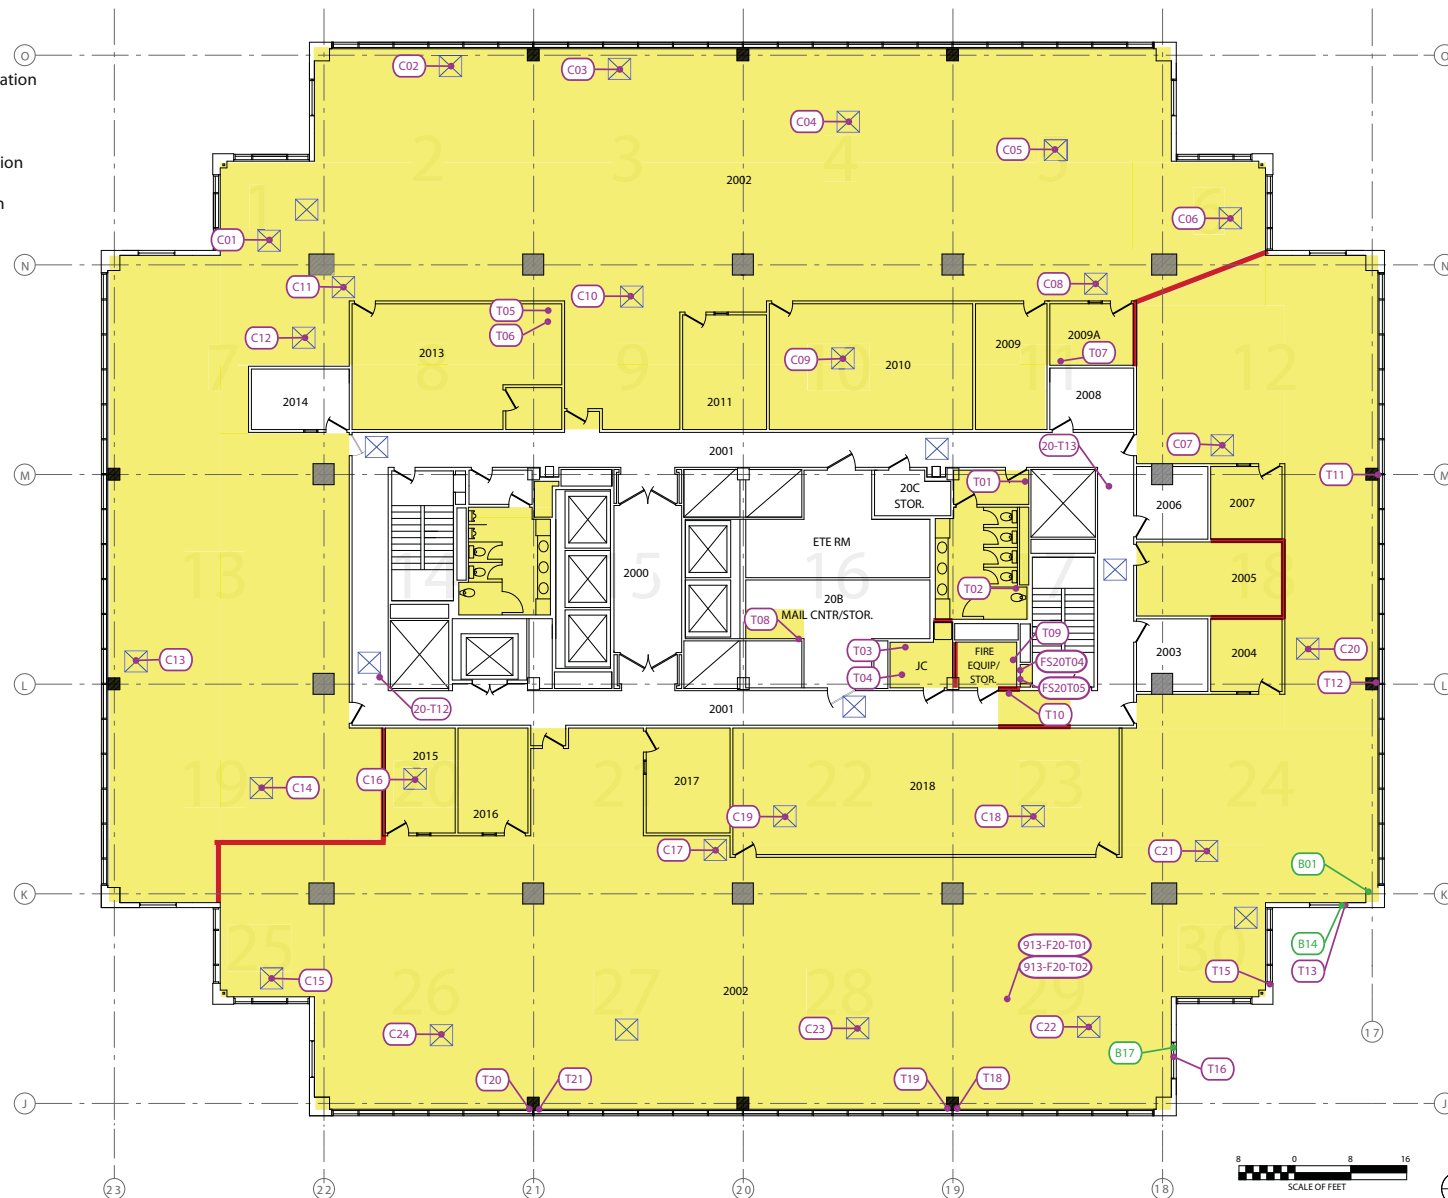
Figure 2

# Containment and Sample Locations (Oct 2012)
